# Debris/Ice/TPS Assessment And Photographic Analysis For Shuttle Mission STS-42

March 1992

National Aeronautics and  
Space Administration

**Gregory N. Katnik**  
**NASA/Kennedy Space Center**

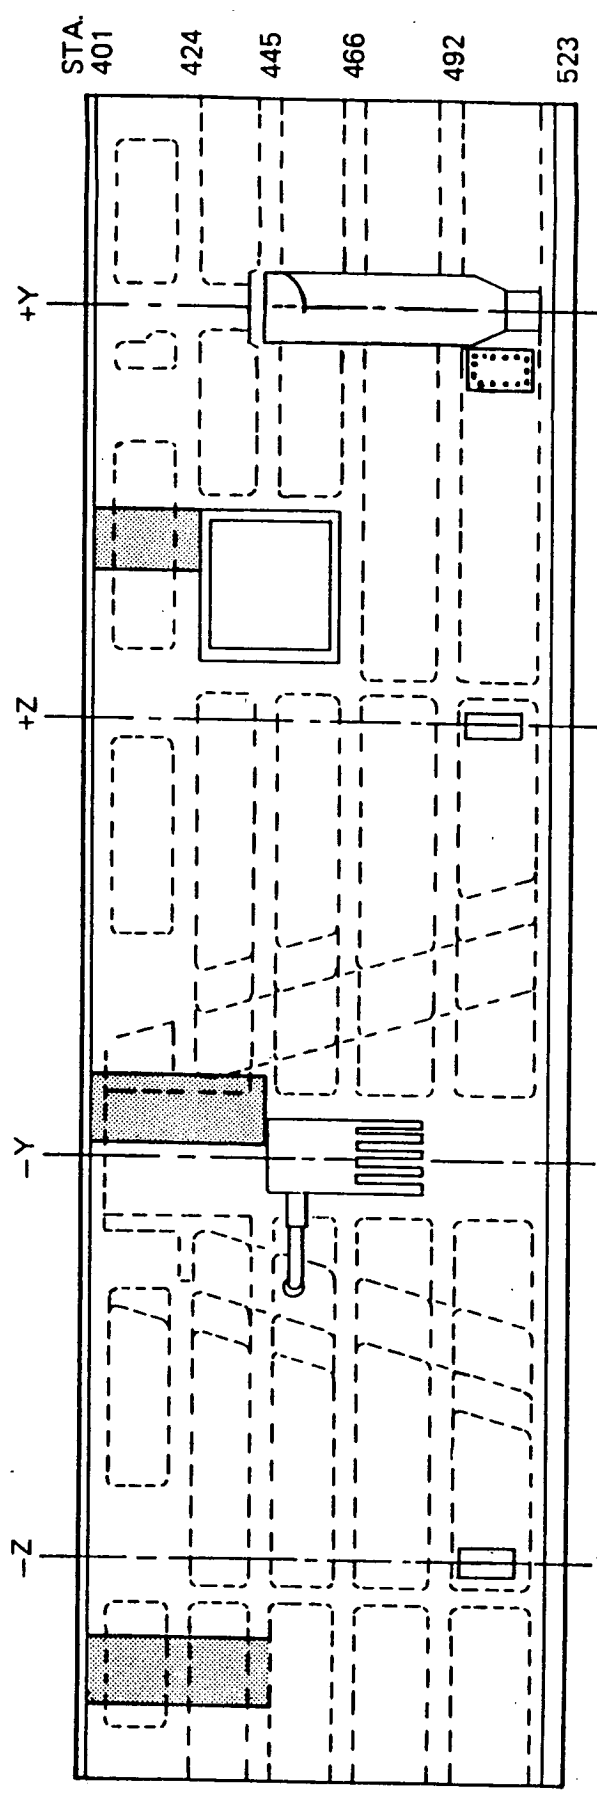
LOCALIZED BLISTERING OF THE  
HYPALON PAINT OCCURRED  
AROUND THE ET/SRB FITTING  
AND SYSTEMS TUNNEL COVER.

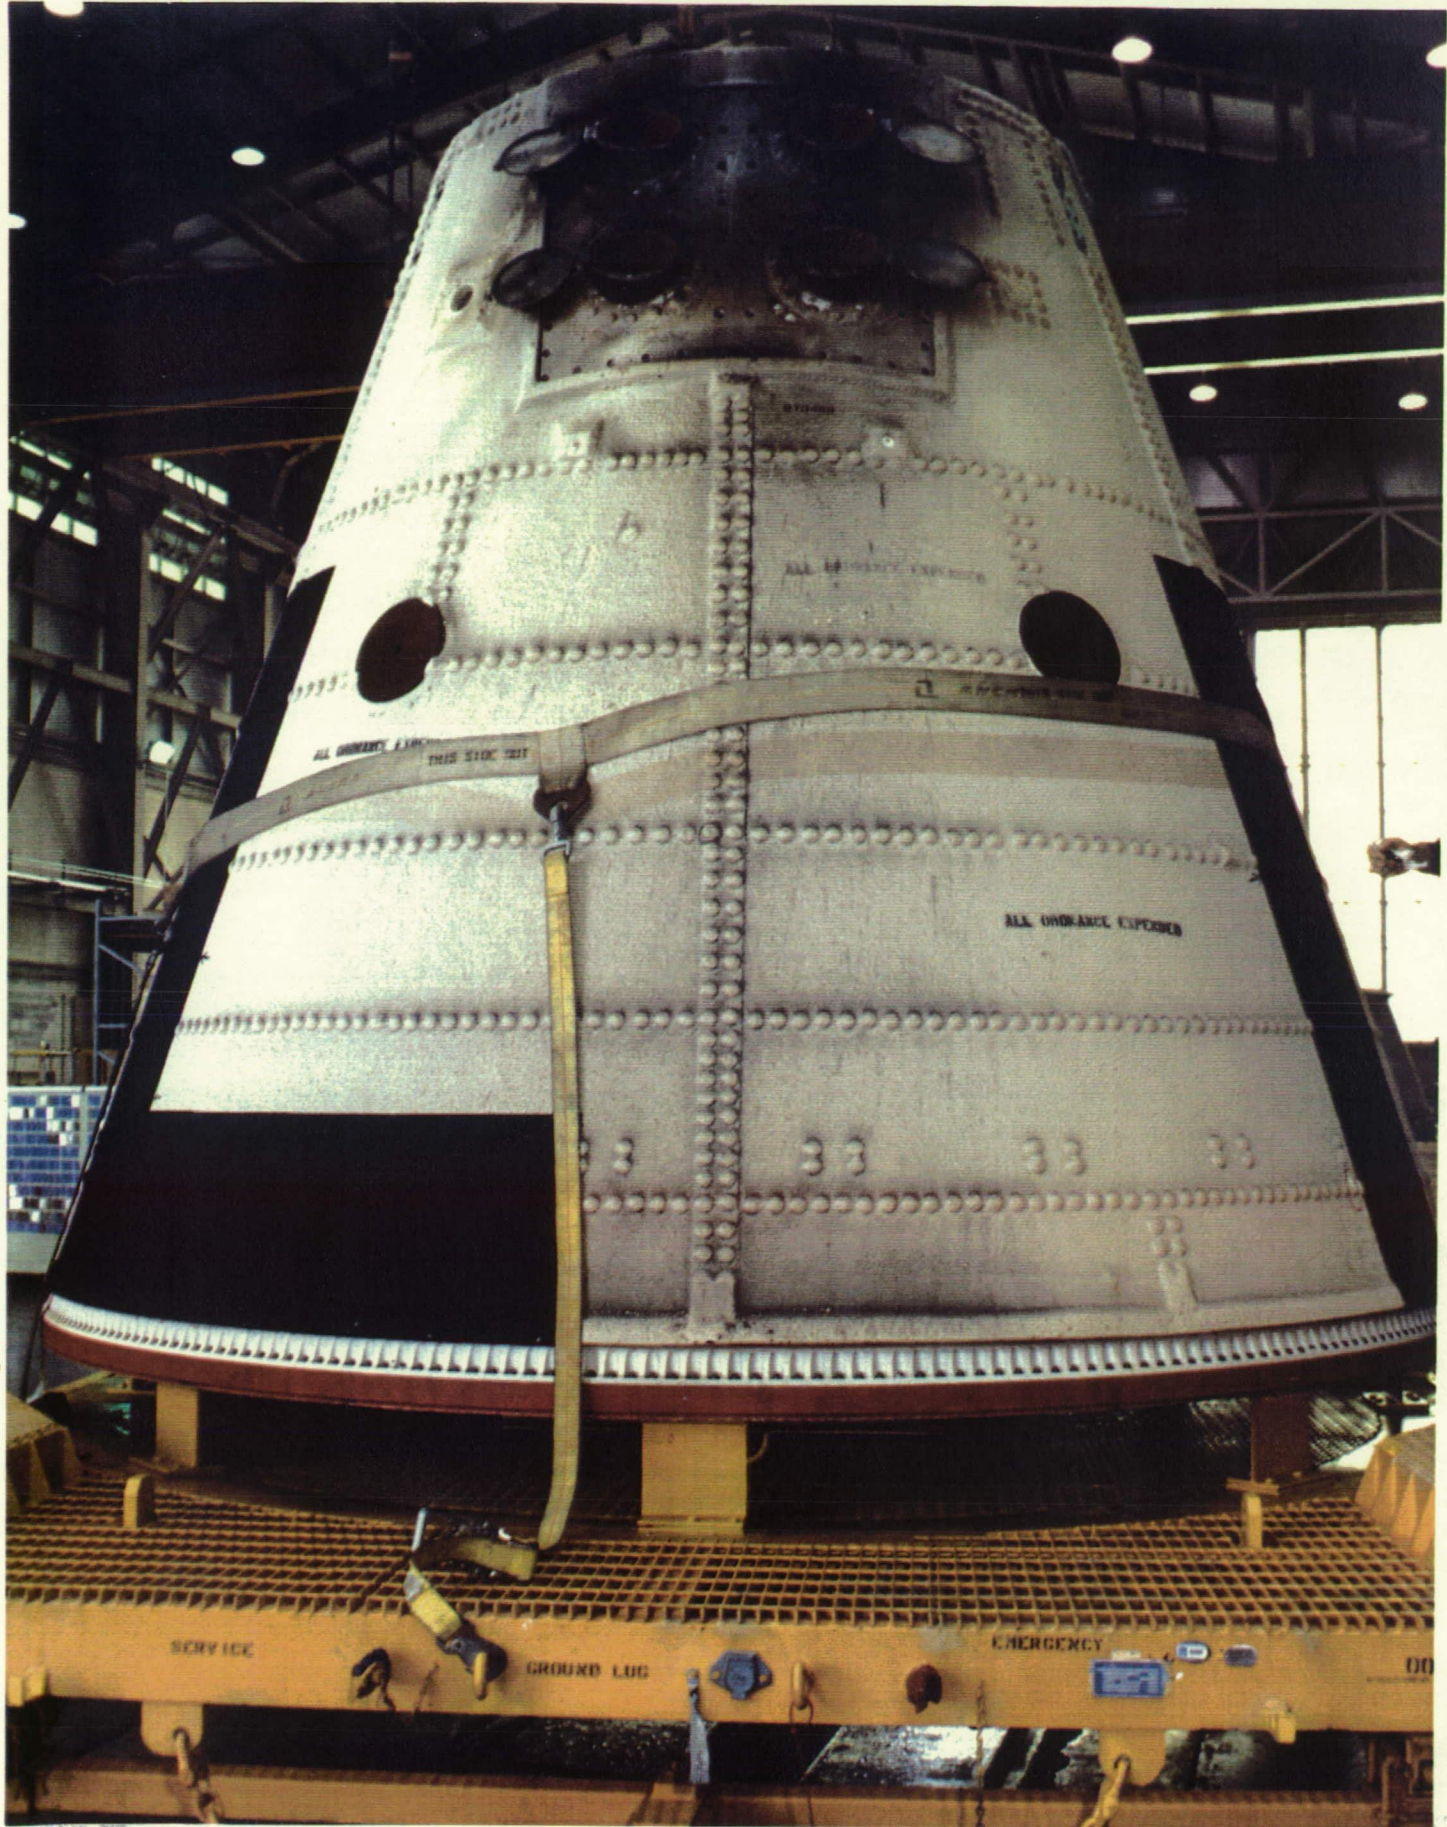
The RH frustum was missing no TPS but had 14 MSA-2 debonds over fasteners. There was minor localized blistering of the Hypalon paint.

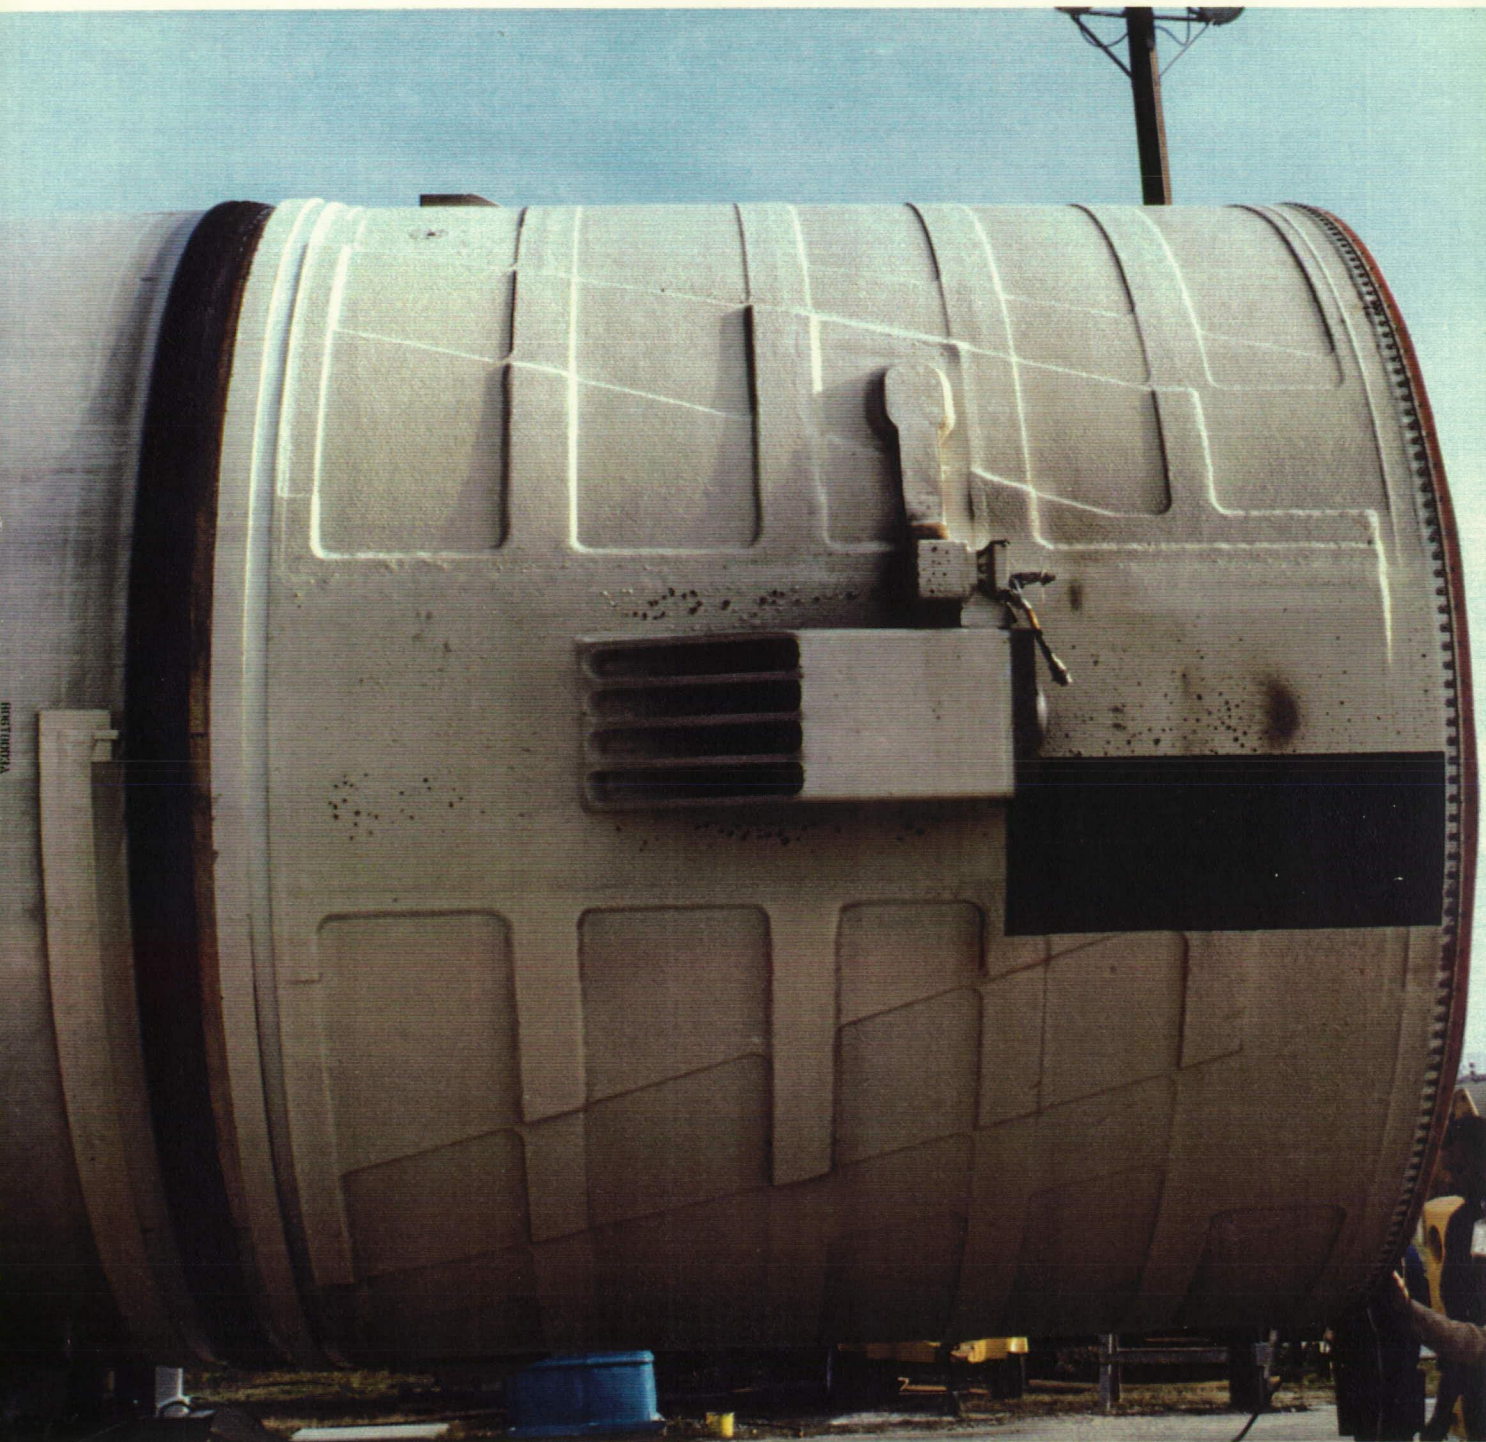
The RH forward skirt exhibited no debonds or missing TPS. Both RSS antenna phenolic plates were intact. Minor blistering of the Hypalon paint occurred around the ET/SRB attach point.

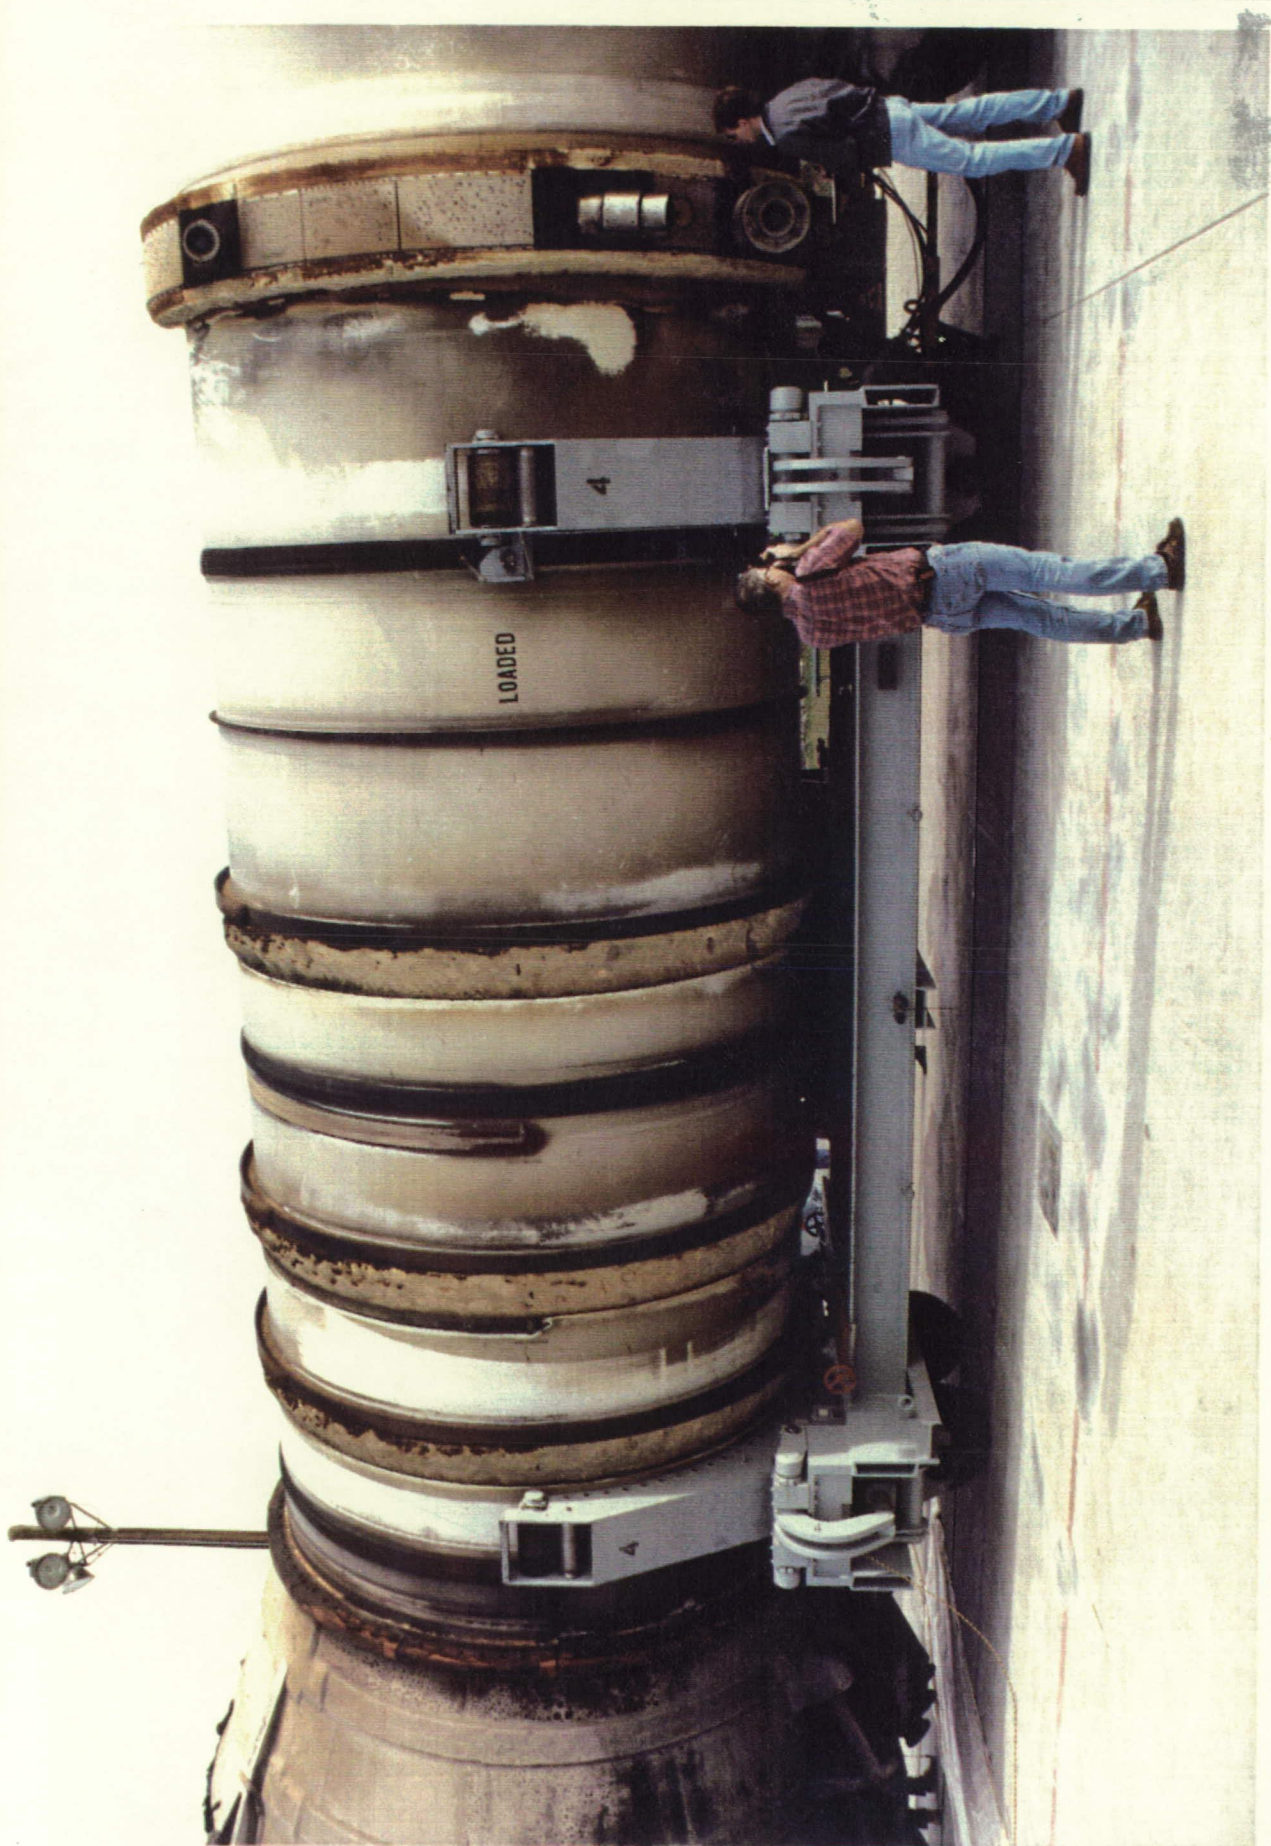
Post flight condition of the RH aft booster. The aft skirt acreage TPS was sooted but in good condition. The ET/SRB aft struts, ETA ring, IEA, and all three aft booster stiffener rings appeared undamaged.

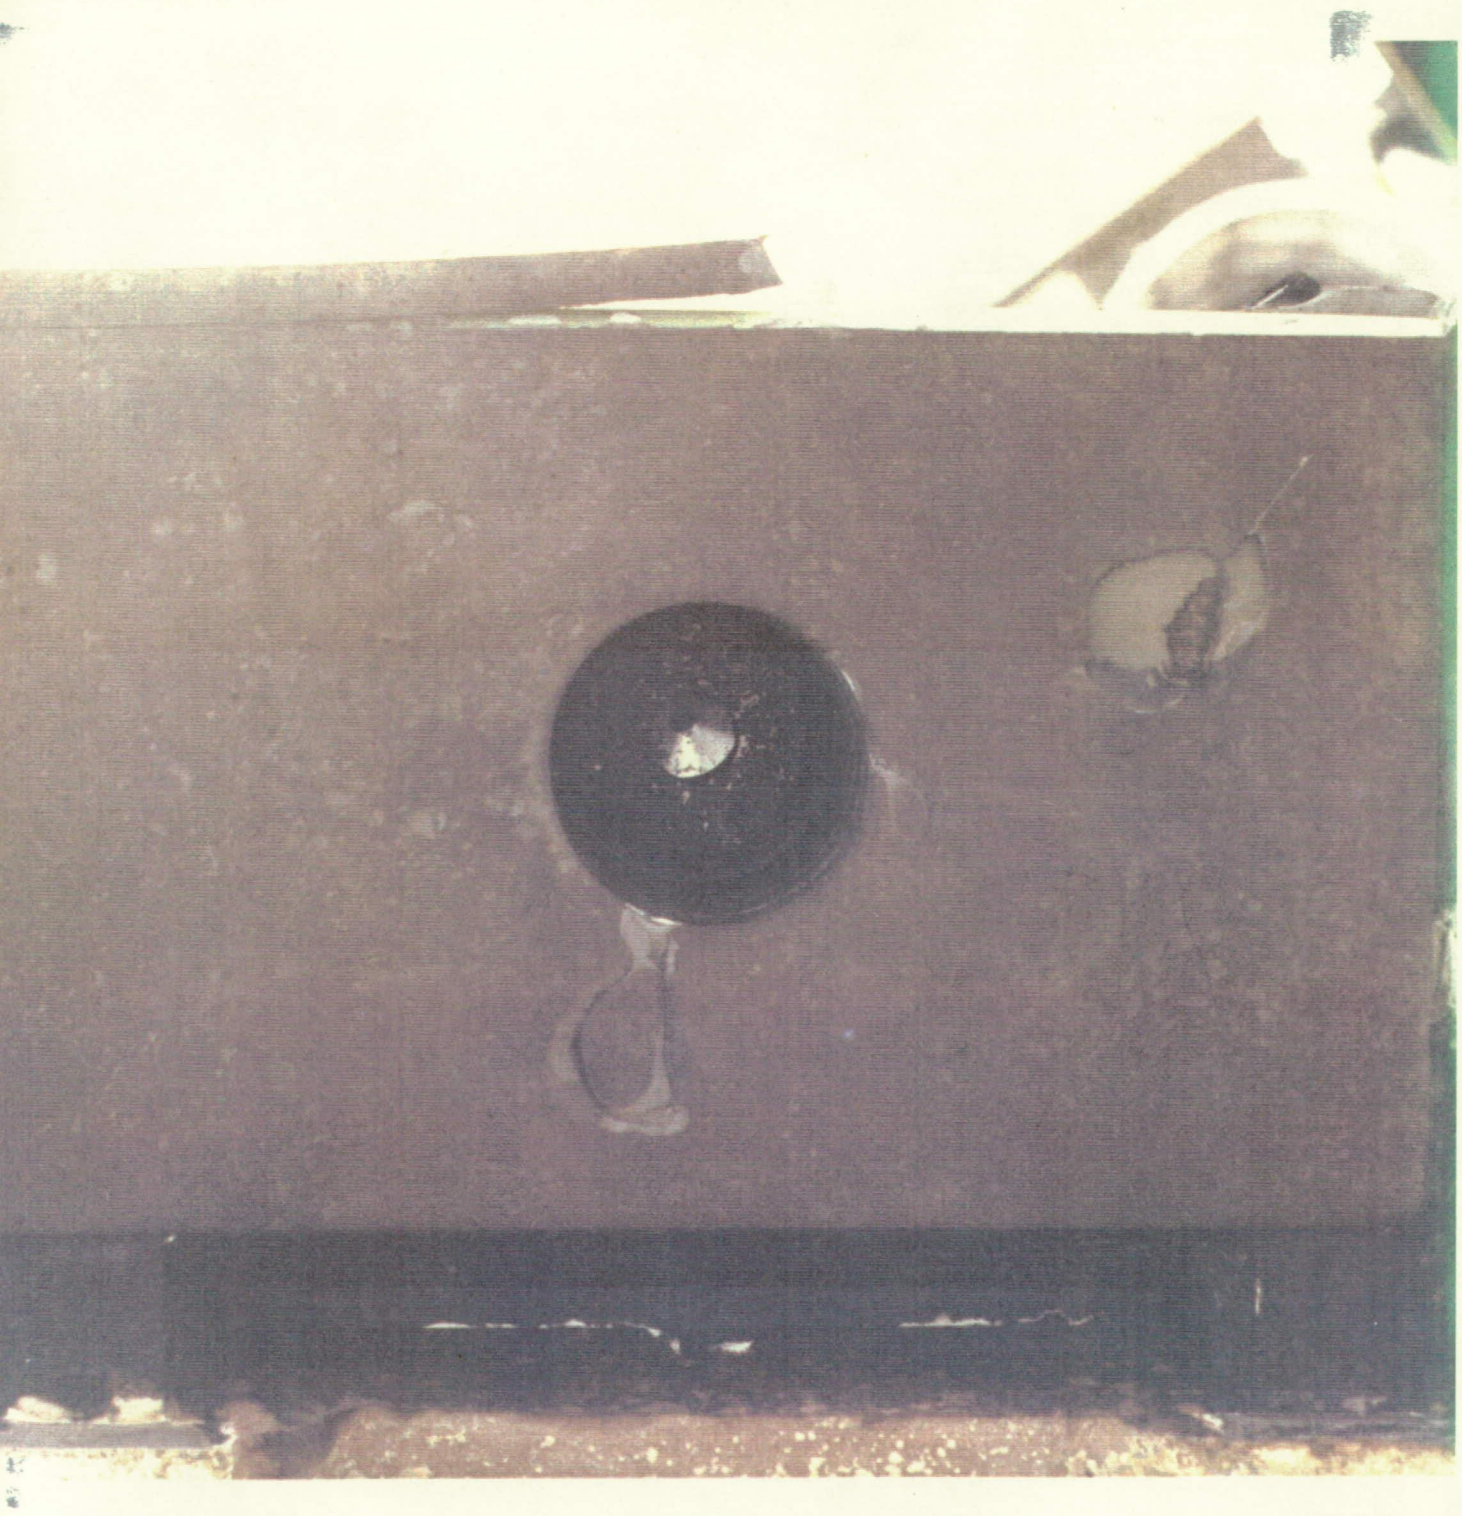
The HDP #3 Debris Containment System (DCS) plunger was not seated. The EPON shim material was almost completely intact.

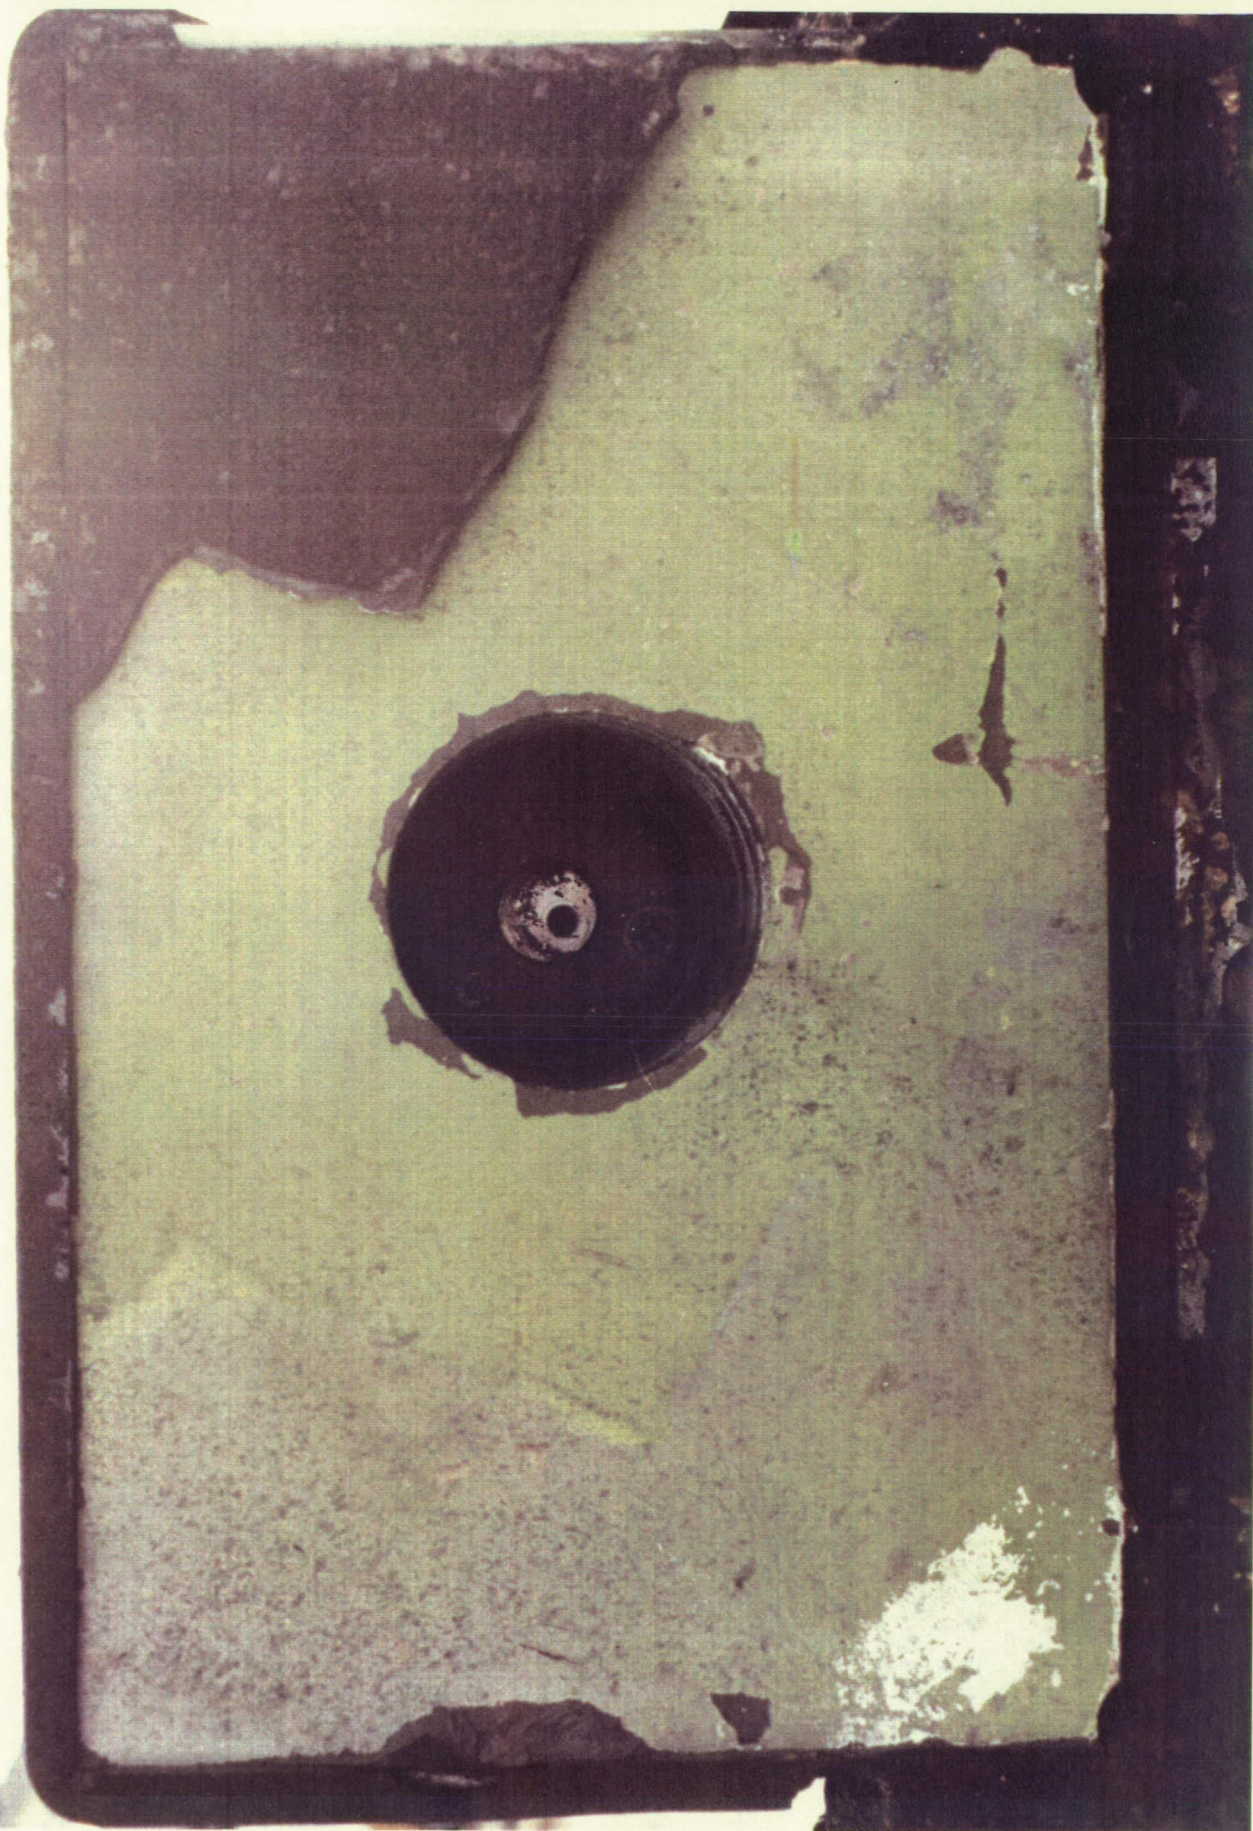
There was no sign of broaching in any of the stud holes. None of the EPON shim material was lost prior to re-entry.

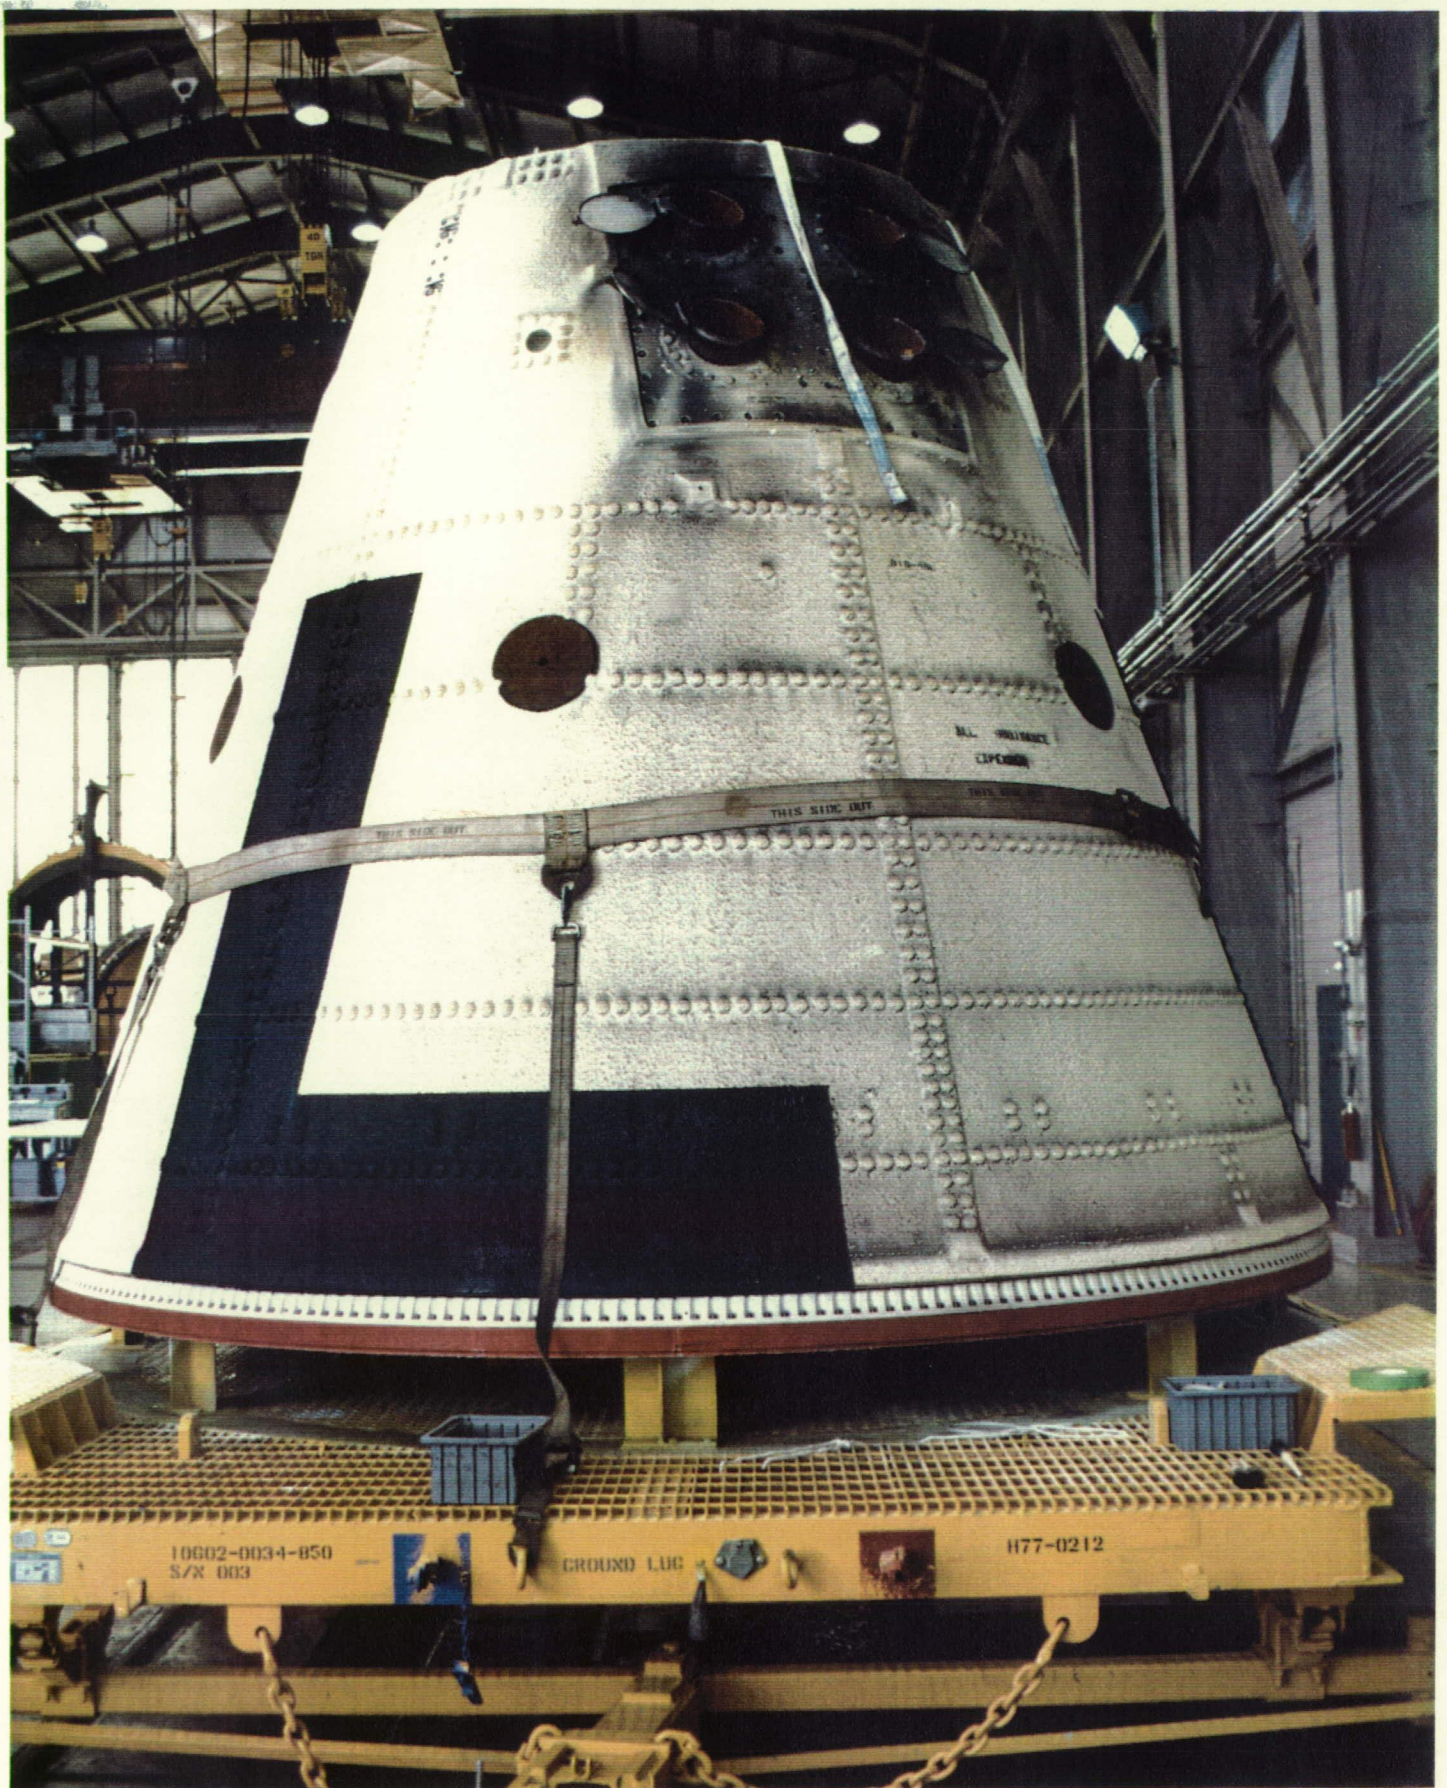
The LH frustum was missing no TPS but had 10 MSA-2 debonds over fasteners. The BSM covers were locked in the fully opened position though the lower left cover attach ring was deformed and the cover bent back to the 150 degree position.

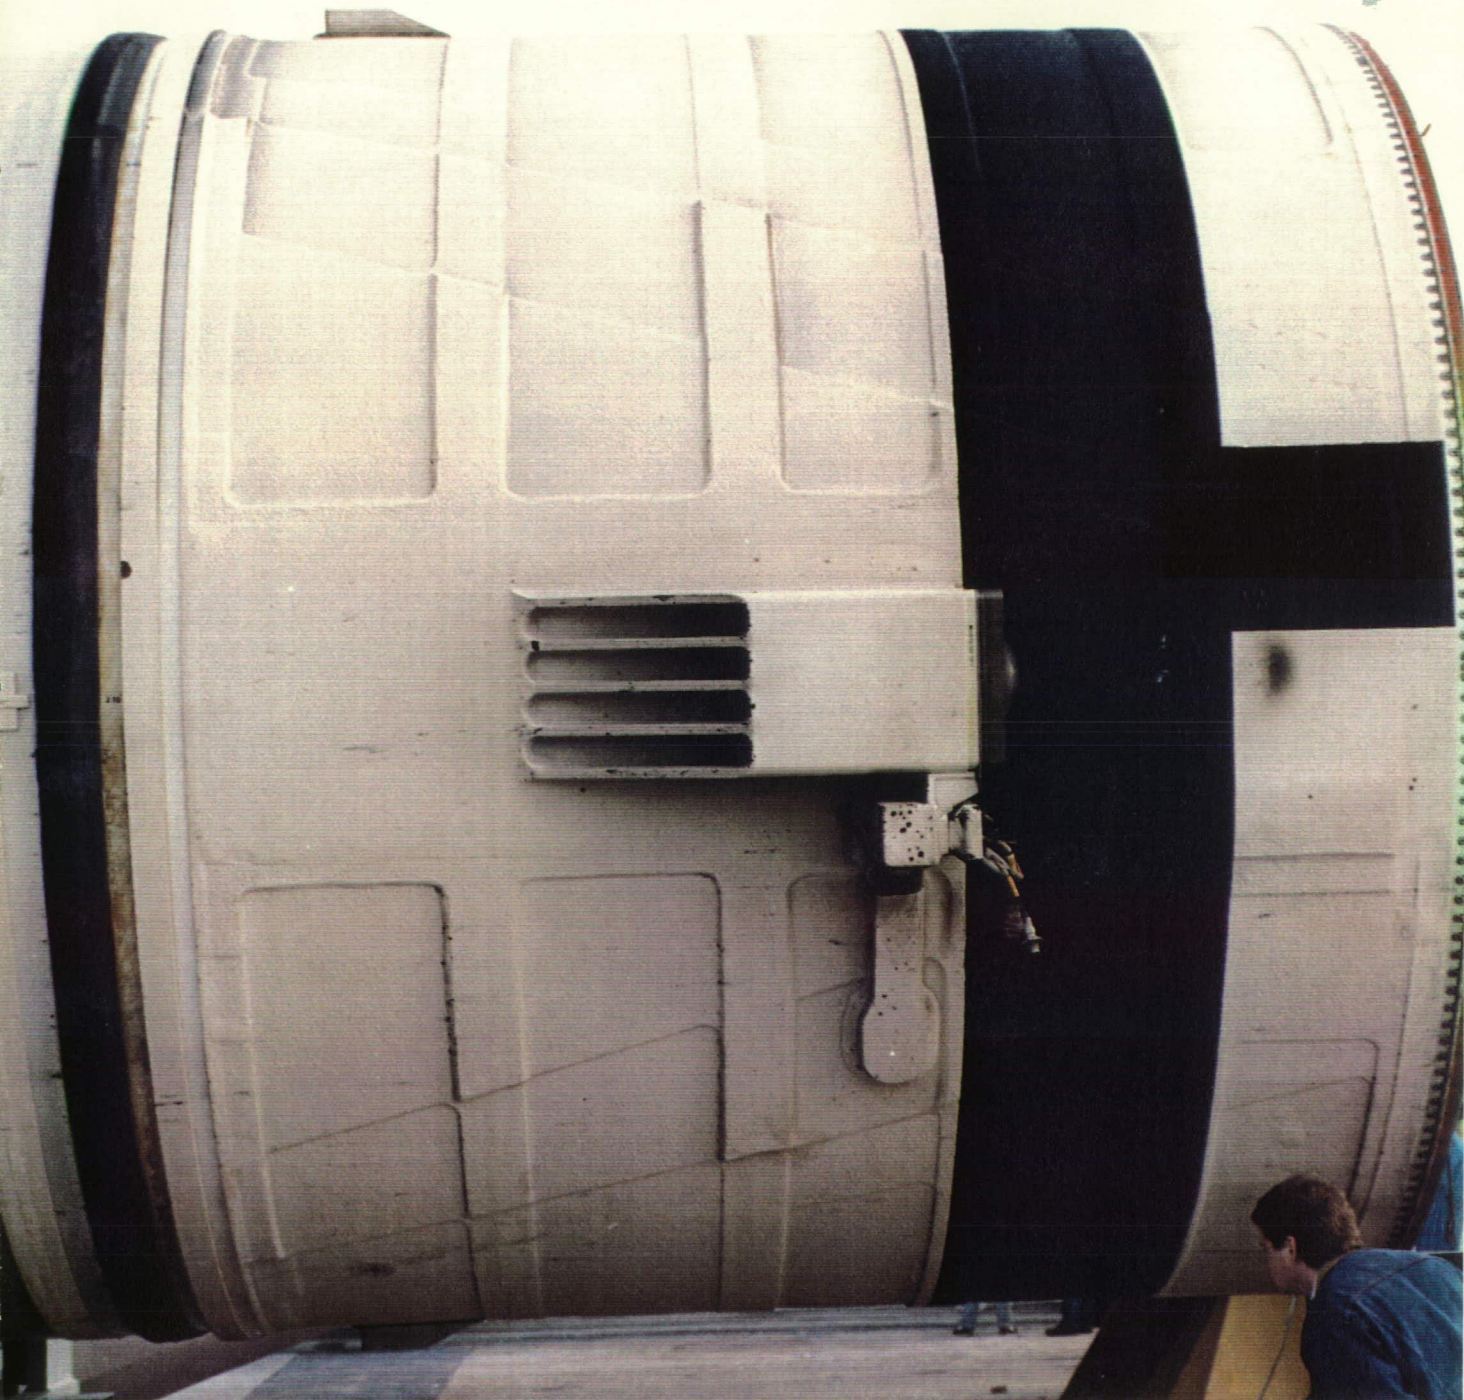
The LH forward skirt exhibited no MSA-2 debonds or missing TPS.

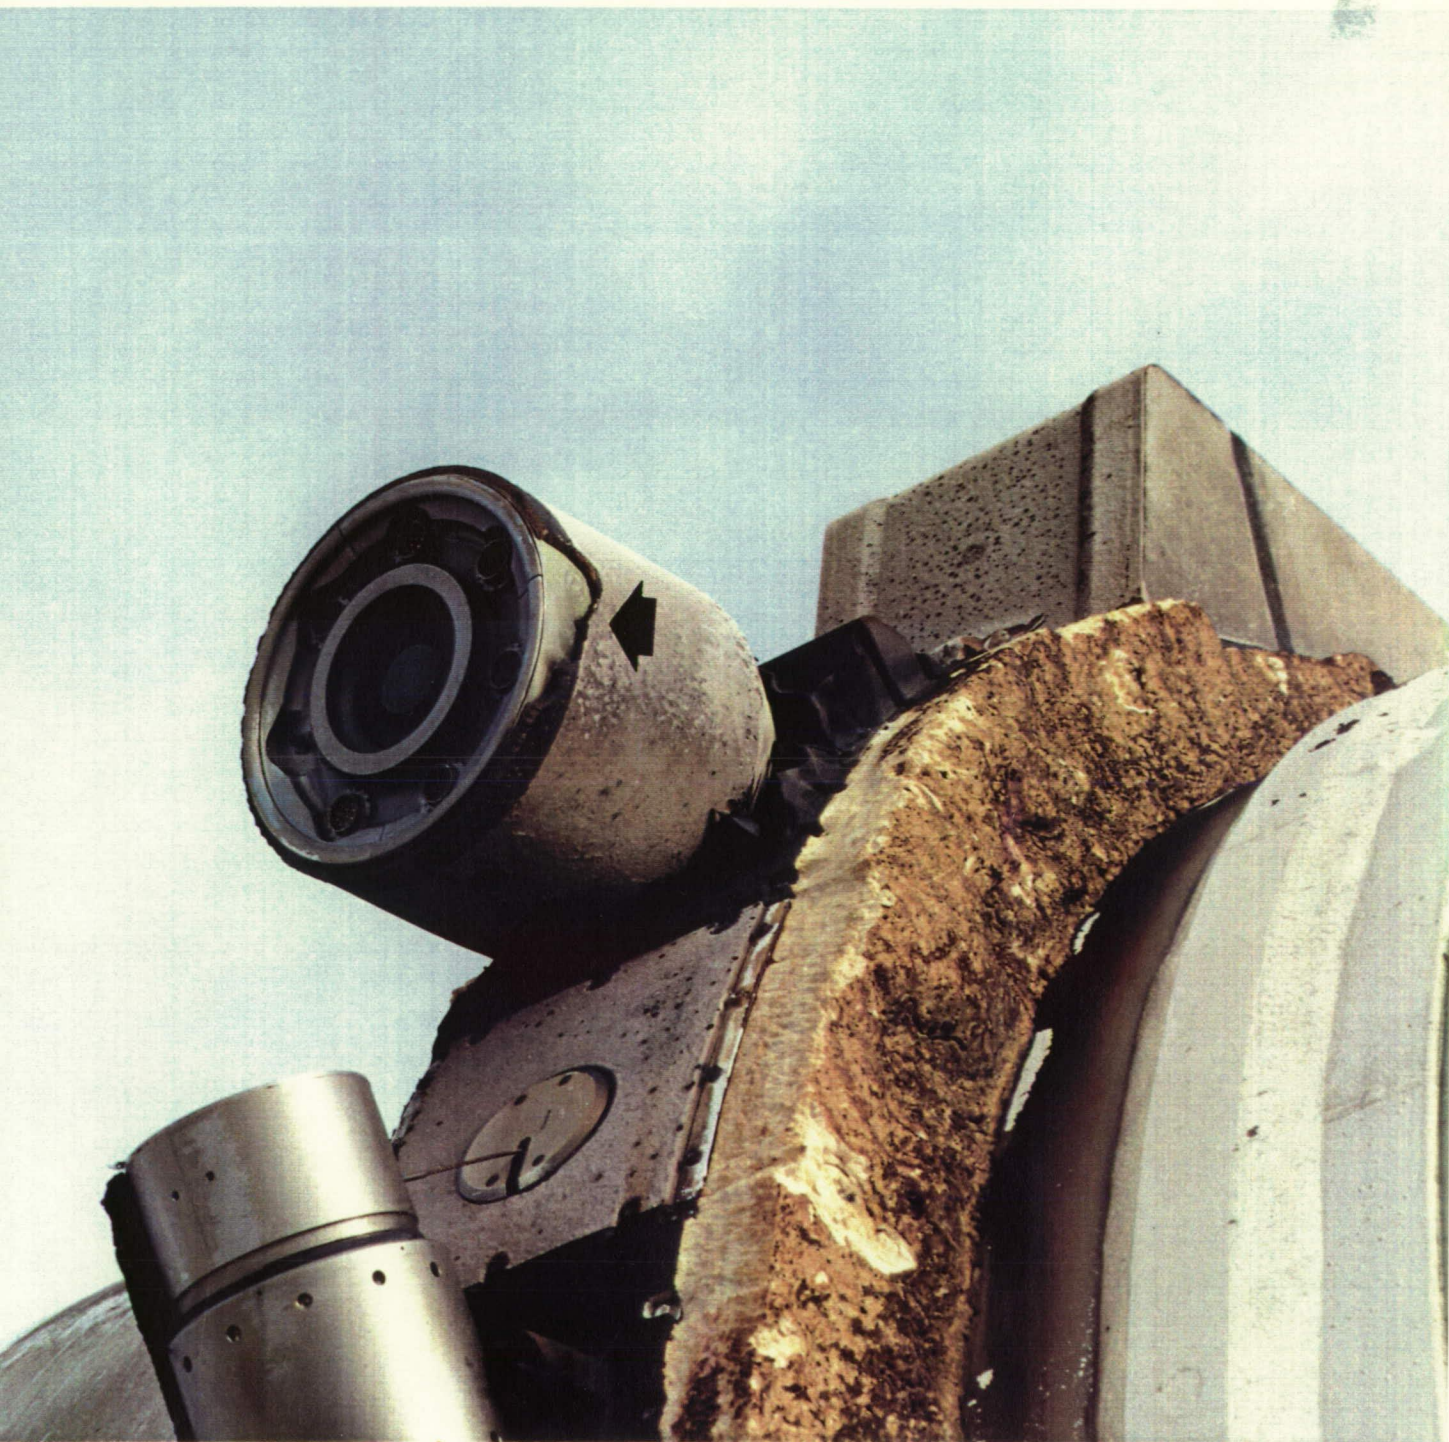
A 3"x1" area of TPS on the forward side of the ET/SRB upper strut fairing at the separation plane was missing and the substrate was charred. The loss of TPS in this area may have occurred during strut separation.

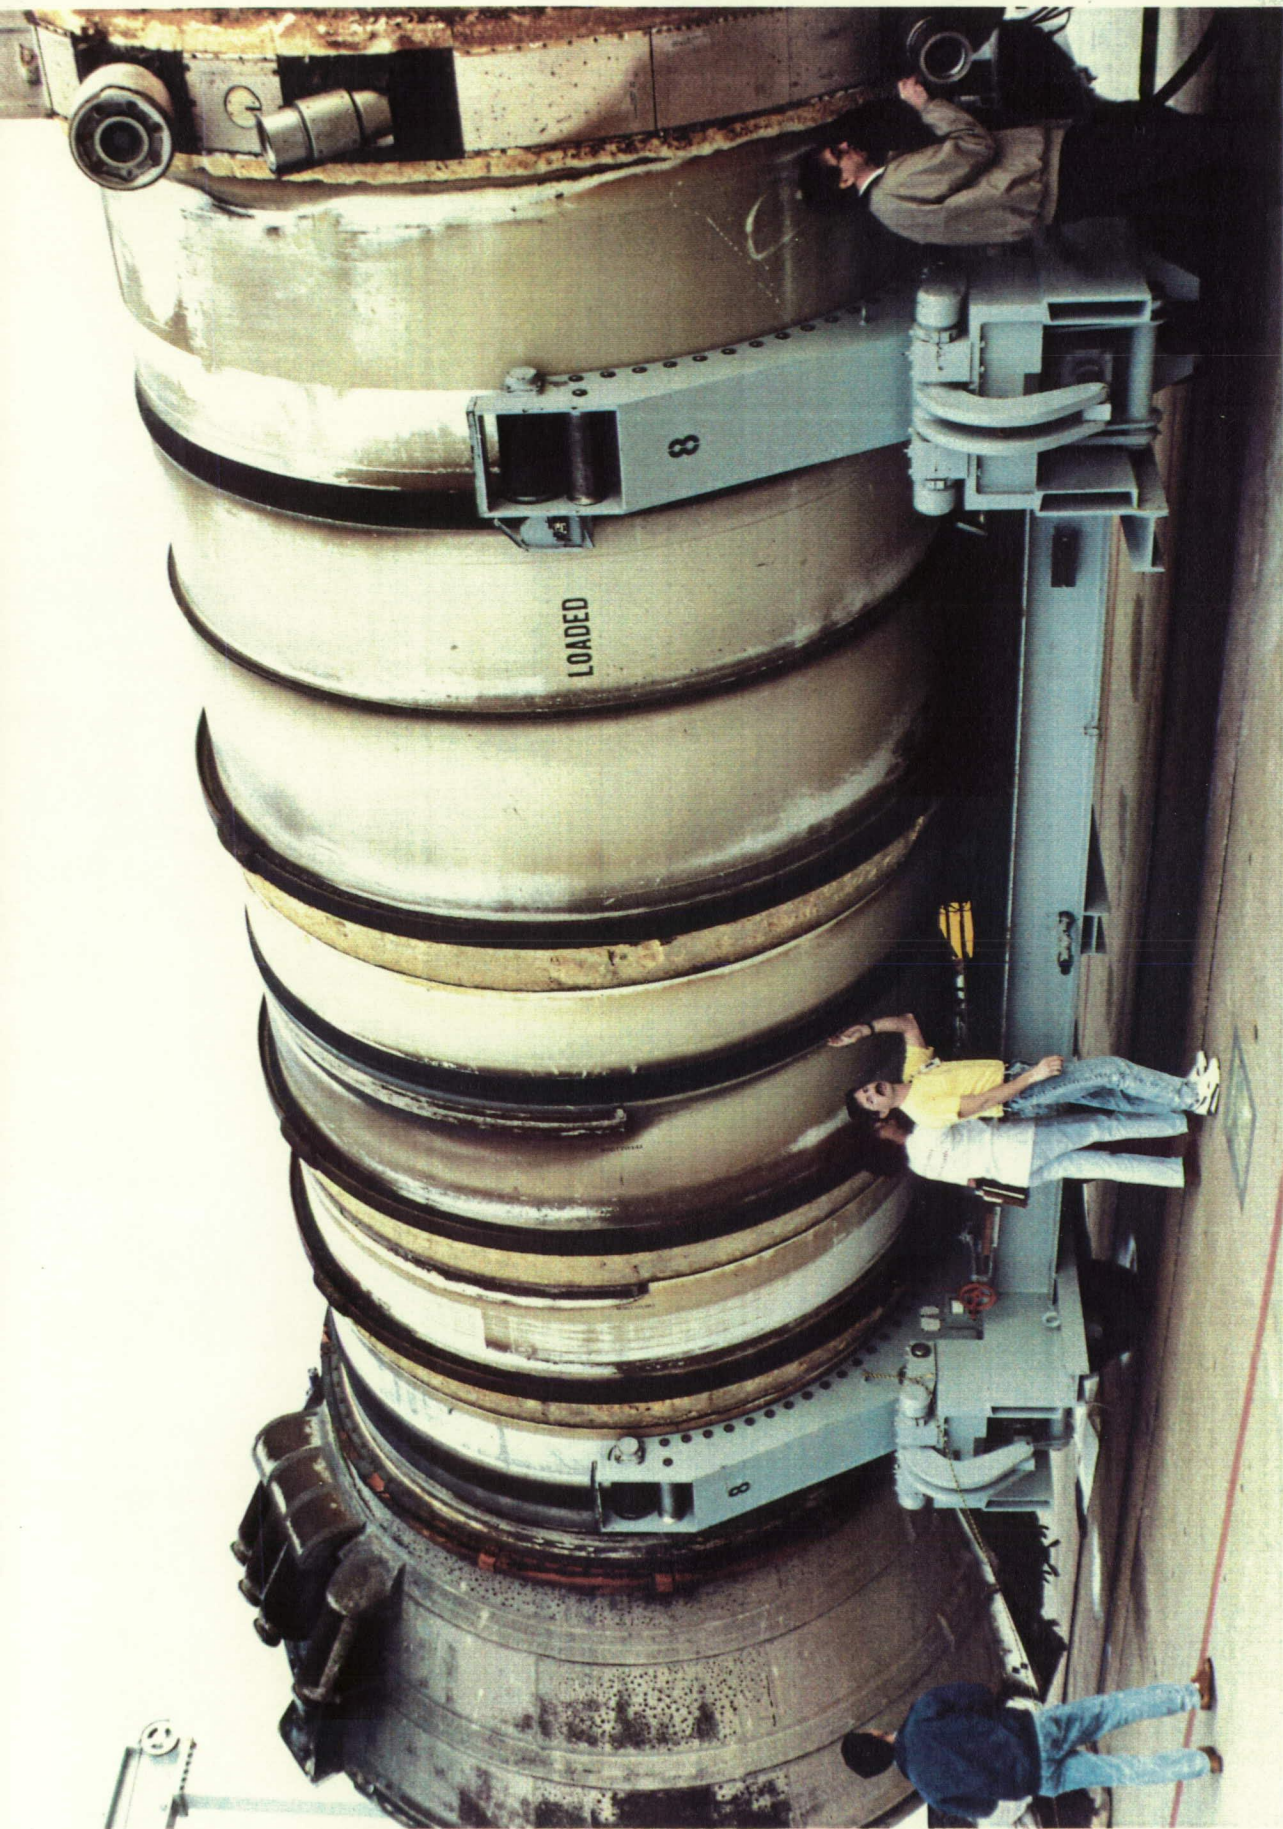
Post flight condition of the LH aft booster. The aft skirt acreage TPS was sooted but generally in good condition. The ET/SRB aft struts, IEA, ETA ring, and all three aft booster stiffener rings appeared undamaged.
